Crack In Transformer Weld

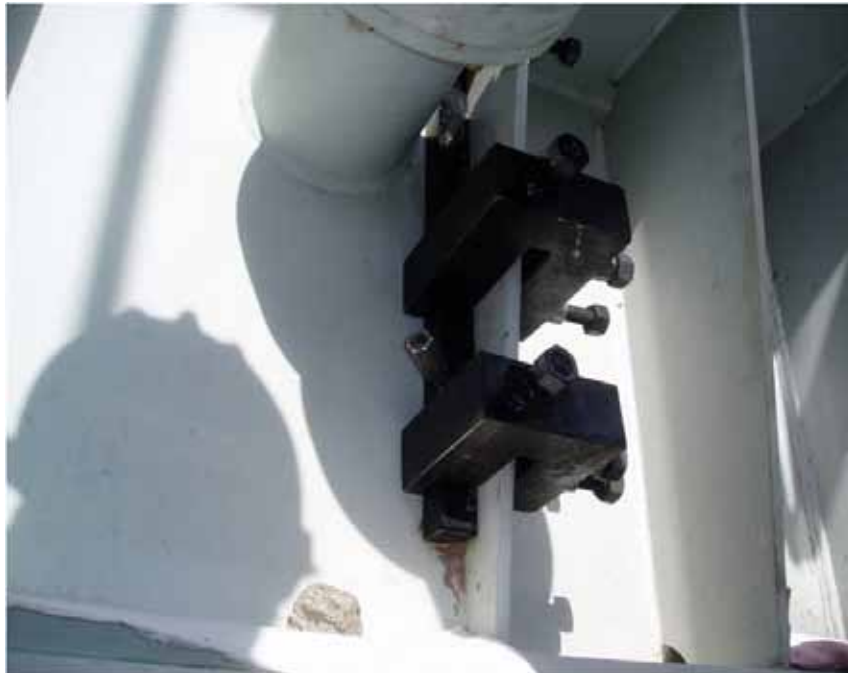
A transformer at a generating station developed a severe crack in a weld located behind a gusset plate. Colt technicians repaired the leaking weld with the unit energized and while it was leaking oil. A blind hold was drilled at each end of the crack to prevent it from increasing in length prior to a Colt, custom repair clamp being installed and sealed. A proprietary, two-part rubber like sealant is hydraulically injected into the clamp to seal the leak. This sealant has excellent dielectric properties and has had dissolved gas analysis completed.
