Generating Station Weld Leak

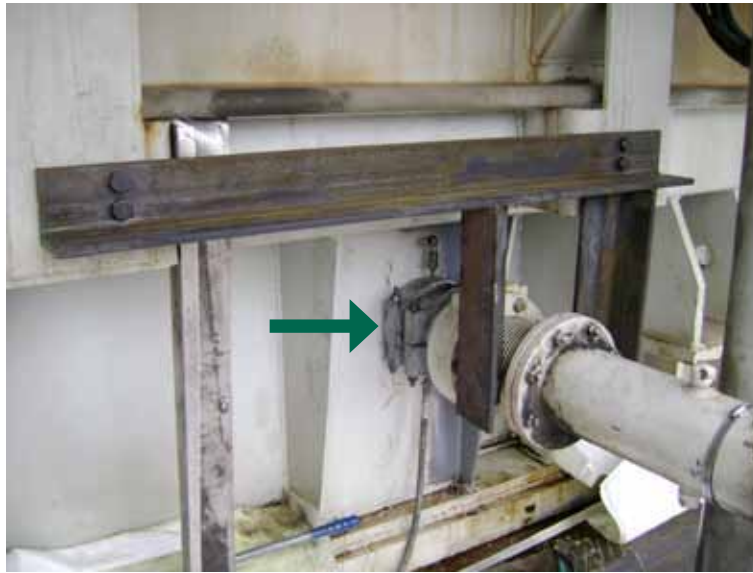
A mid-west generating station developed a leak on a weld where a six inch oil line was attached to the transformer wall; the crack was running around the diameter of the weld. Colt technicians gathered measurements needed to design and fabricate a repair clamp. The clamp was made overnight and delivered to the plant the next day. The repair consisted of a split ring clamp (arrow) that was bolted around the pipe and had two seals, one that set against the wall of the transformer and the other that went around the six inch pipe. A second clamp was installed (strong back) to use jack bolts to push the first clamp up against the transformer wall; this jacking affect also had the side affect of wanting to push the six-inch pipe away from the transformer wall. To overcome this additional steel angle, iron was attached to the unit and jack bolts were used to push everything back into place (double strong back). The repair was completed with the unit energized.
