September 10, 2014

<u>REPORT ON SF6 LEAK REPAIR COMPLETED AT SOUTHERN CALIFORNIA</u> EDISON (SCE) VALLEY 115kV GIS - SECTION 119C

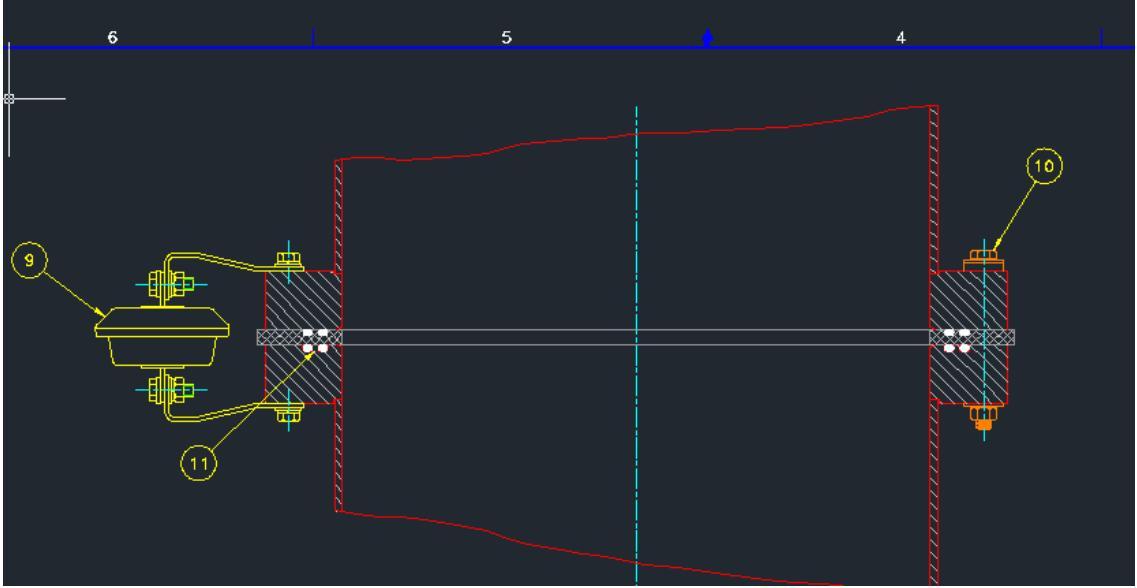
Diagram 1

Joint consists of two painted aluminum flanged sections mated vertically with an approximate 0.5 inch thick insulator sandwiched between the flanges. Since this is considered an insulated joint, the Colt clamp will need to be non-conductive. Diameter of each flange is 25 inches x 2" thick. Diameter of pipe is 20 inches. Internal pressure is 67 psig SF6.

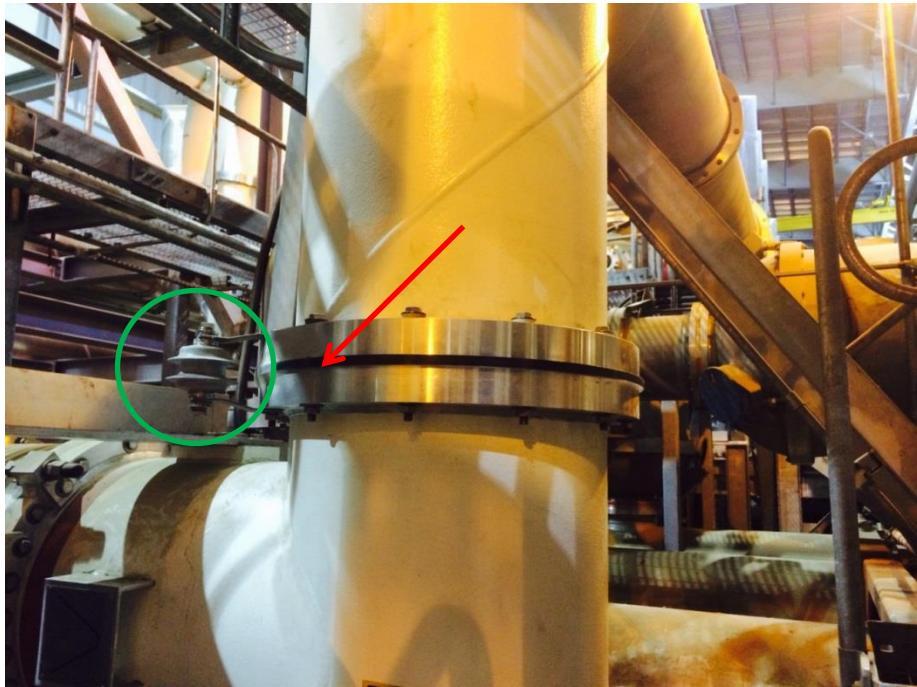
Client photograph of Section 119C

SF6 leaking from the flange as indicated by red arrow in the photo below (gas zone 119 C phase). It is right behind the surge arrester in the photo. The leak was found using an

SF6 detection camera. Maintenance attempted to slow the leak using epoxy, but it did not work. SCE was adding about 66 lbs of SF6 per month to this section.

Colt's solution will require the surge arrester to be removed and relocated in order for a custom enclosure to be installed on the flange.

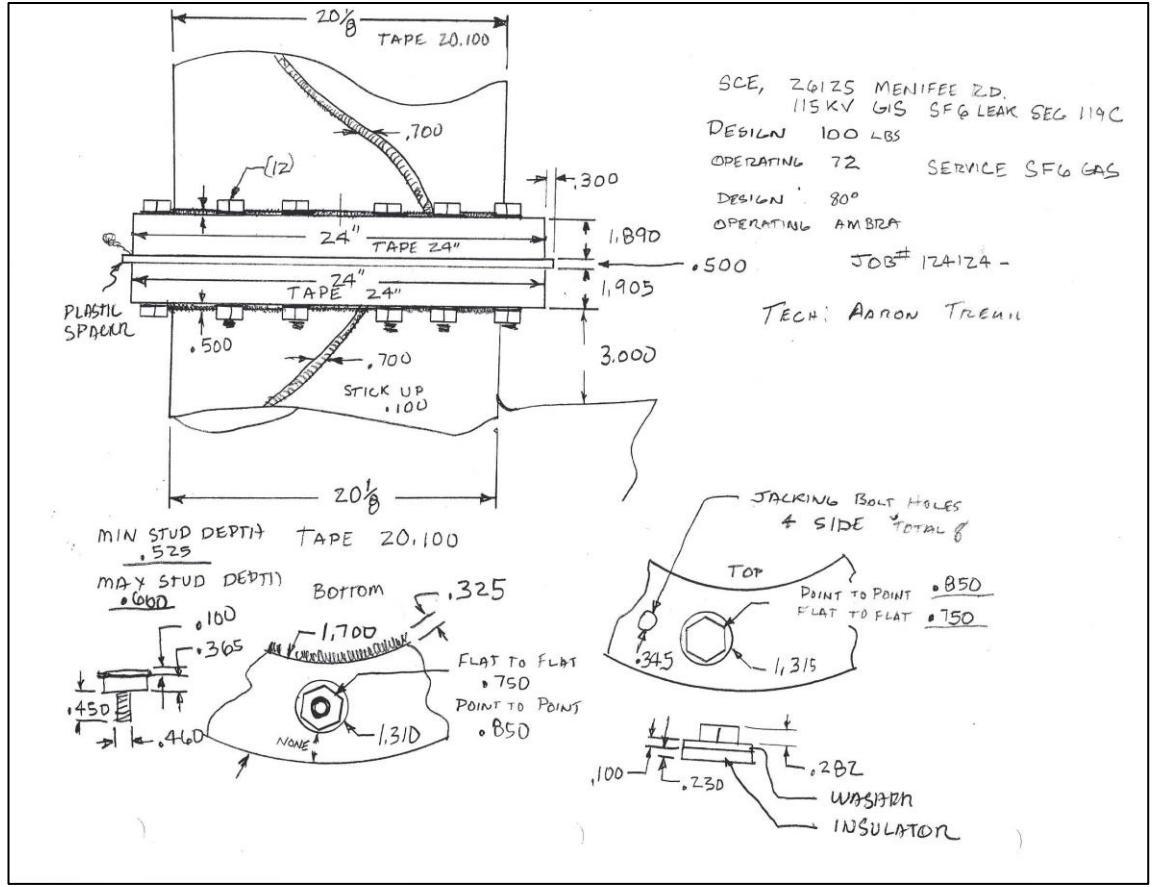
Diagram 2 – Colt technician measurements

Colt technician made on-site inspection, took additional photos and precise measurements. (*See Diagram 2*)

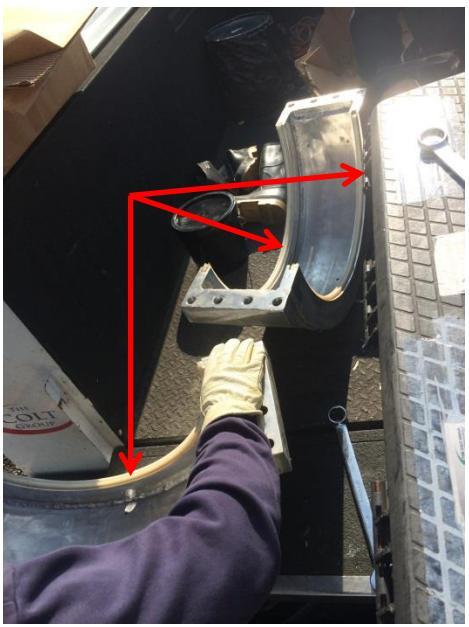
Photo of open enclosure, noting nylon inserts

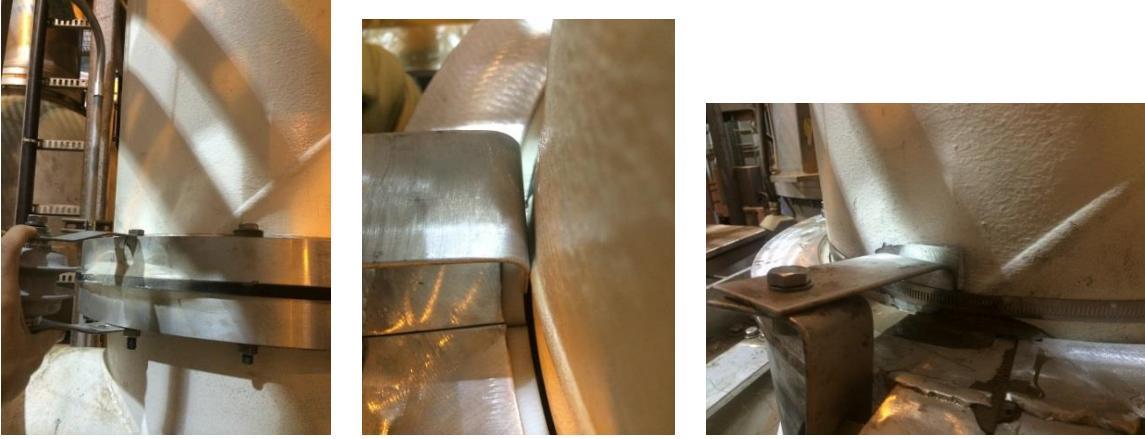
Original Surge Arrester location – after removal. Bracket bent and moved to left.

Surge Arrester bracket bent and moved to the left to avoid spiral weld.

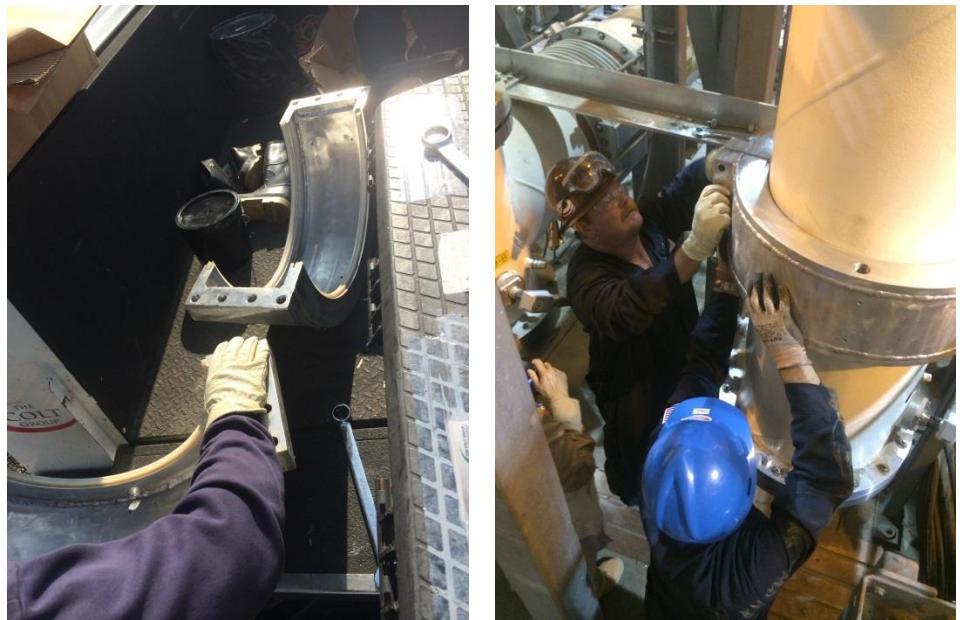
Sections of enclosure- open

Enclosure being installed by Colt technicians

2) Colt installs custom enclosure.

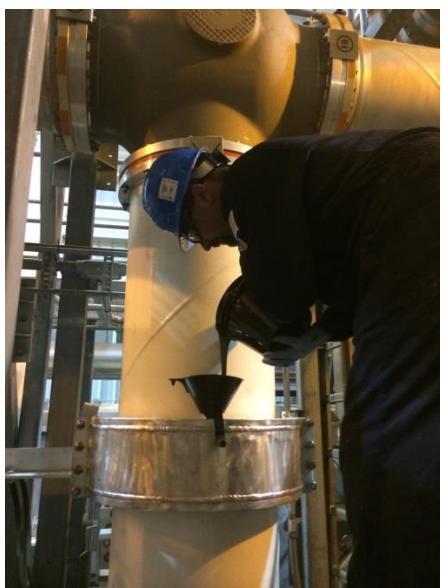
Sealant being poured in from the top to ensure rapid fill and even curing.

3) Sealant is poured in. The two-part compound is mixed and poured in via one inch ports incorporated into the top of the enclosure.

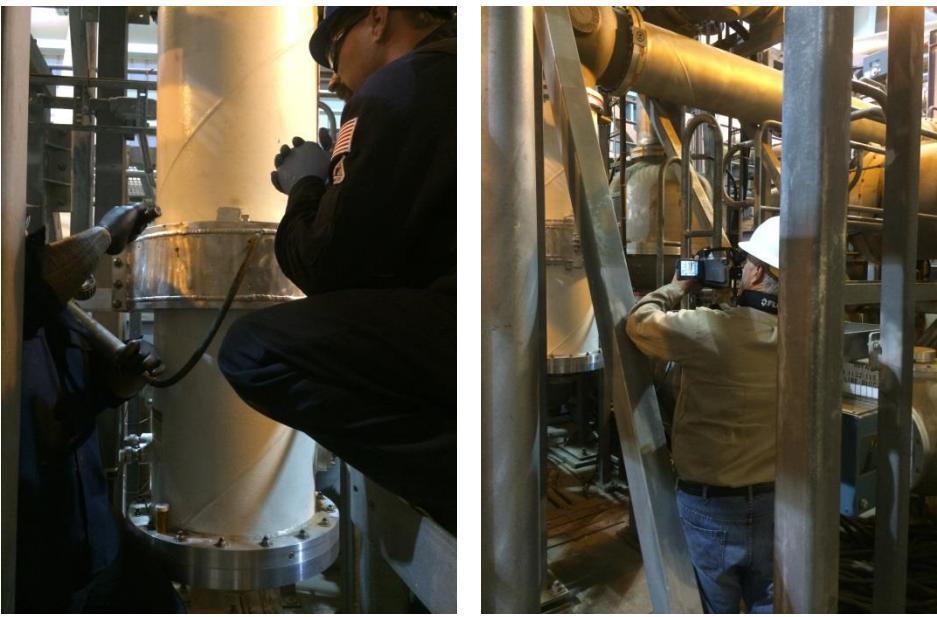
Colt sealant injection

1) Colt hydraulically injects additional sealant through injection valves along the sides of the enclosure.

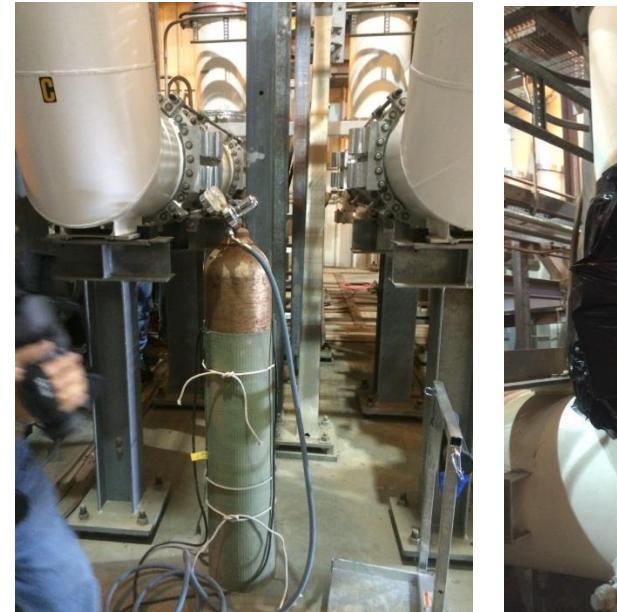
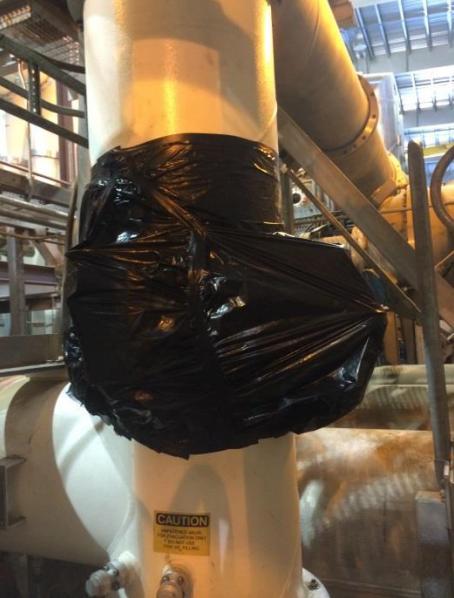
- 1) SF6 is brought to full pressure.
- 2) Leak is confirmed to have stopped.
- 3) Flange is bagged for 12 hour gas leak detection test.
