CT Leaks Repaired In Place

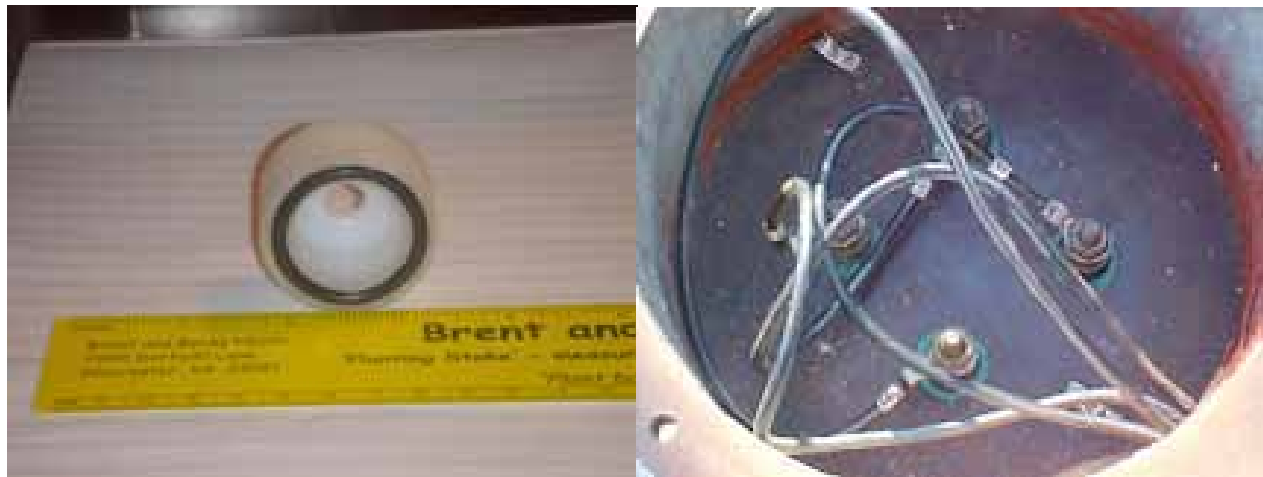
Colt technicians have repaired thousands of transformer oil leaks using our proven injection process. One way to make a repair to a leaking CT is to encapsulate the leaking stud with a custom enclosure made from a low absorption material. The nut and wire are removed, the stud enclosure is installed over the leaking stud/studs. A nut is installed, then the wire and finally a nut to hold the wire. The completed assembly is then injected with our S-22 sealant compound.
