Flapper Valve Flange Leak

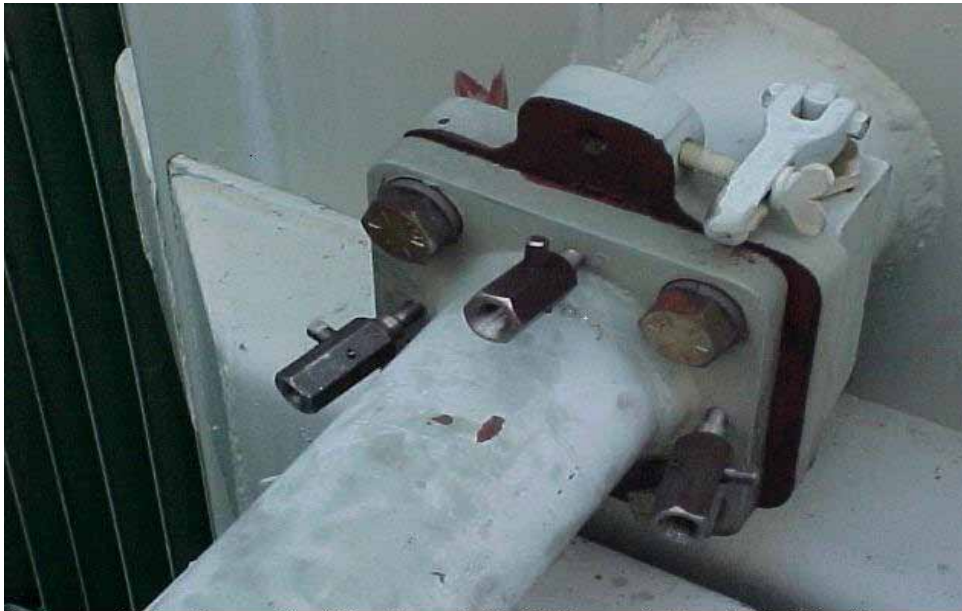
A Flapper Valve Flange That Has Been Drilled & Tapped - Ready For Injection

Colt technicians have repaired thousands of transformer oil leaks using our proven injection process. The repairs are completed while the leak is active and in many cases are done with the unit energized. After the sealant has been hydraulically injected, the injectors (shown above) are removed and Teflon coated pipe plugs are installed. The proprietary, two-part rubber like sealant will not bond to the flanges and maintains a “memory” that allows the sealant to expand and contract as needed due to the temperature changes and vibration. This sealant has excellent dielectric properties and has had dissolved gas analysis completed.
