SF6 Gas Leaks Repaired Under Pressure On Bus System

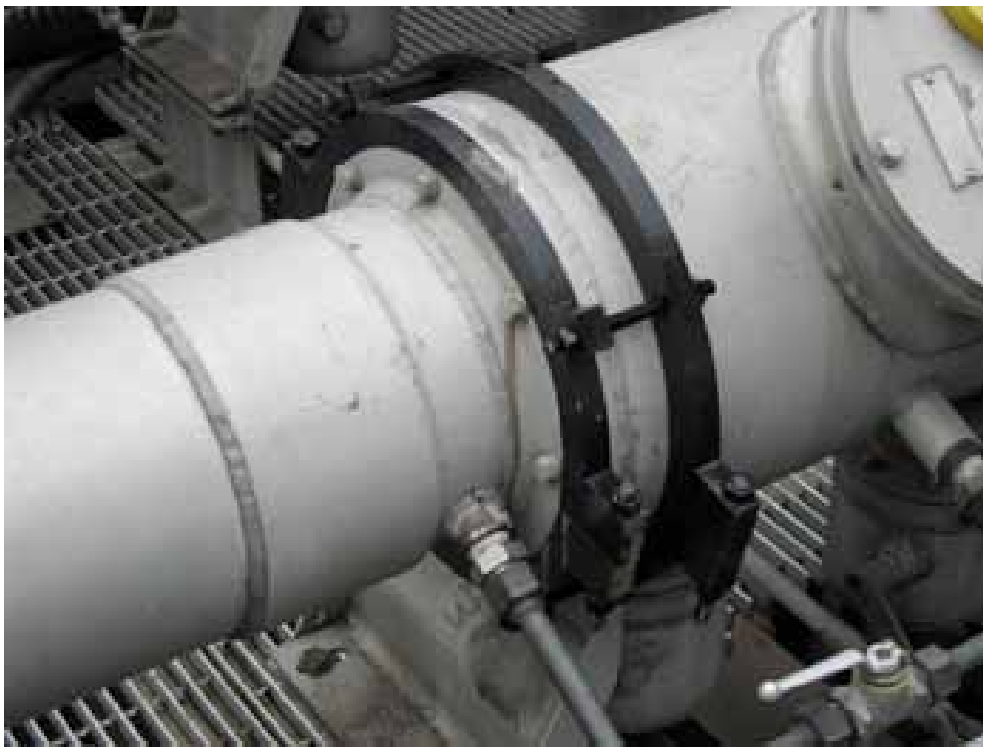
SF6 gas circuit breakers and insulated bus systems are prone to leak. The picture above shows a flange that has been repaired by Colt technicians with the system in-service and under pressure. A custom manufactured repair clamp is installed and then hydraulically injected with our S-22 sealant to stop the leak.
