Side Mounted Bushing Leak

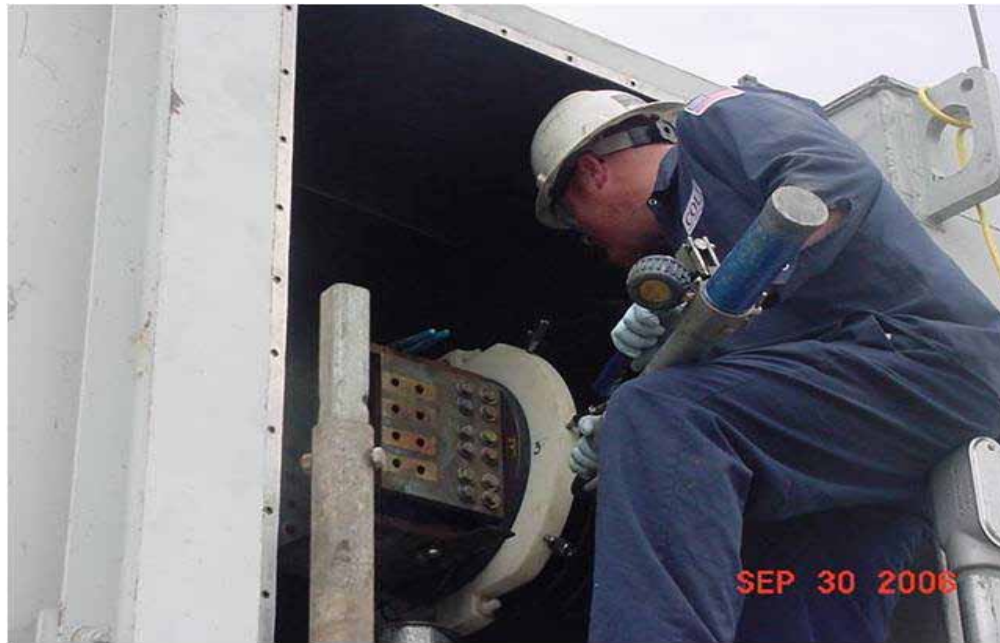
A side mounted bushing leaking between the aluminum and porcelain is repaired by the Power Services Division of Colt without draining the oil or disassembling the bushing. The repair utilizes a custom designed clamp manufactured by Colt from a low absorption, cast nylon material. The clamp is manufactured at the company's machine shop facility and is on the job site within twenty-four to thirty-six hours. A proprietary, two-part rubber like sealant is hydraulically injected into the clamp to seal the leak. This sealant has excellent dielectric properties and has had dissolved gas analysis completed.
