# Transformer Oil, Nitrogen, Silicone and SF6 Gas Leak Sealing Examples

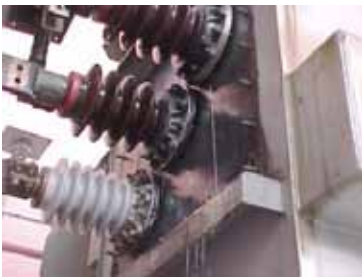
Leaking Bushing Flange prior to the Clamp Installation

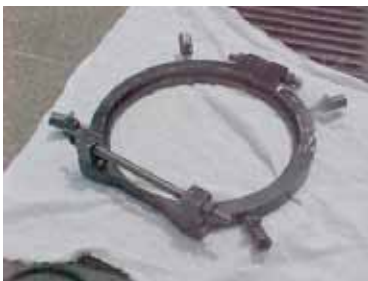
Emergency Custom Fabricated Bushing Clamp

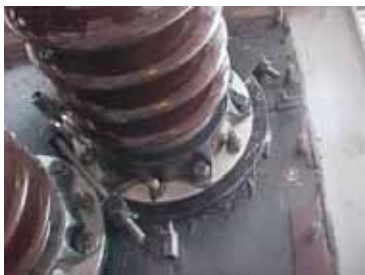
Leaking Bushing Repaired

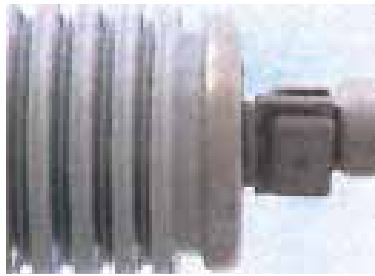
SF6 gas 345kV Breaker Bushing Terminal Ends are notorious for leaking where the porcelain goes into the aluminum terminal end. The clamp below is made of cast nylon and would be one style of clamp made for this repair. The clamp and cured sealant are easily removed at a later date.

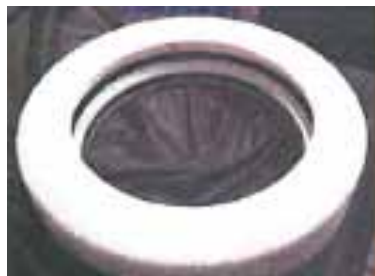
Cast Nylon Clamp with rubber seals is designed to close on the OD of the aluminum terminal end then drop down and close on the porcelain OD. This will create a barrier around the entire leaking area that will then be injected with Colt's S-22 sealant.

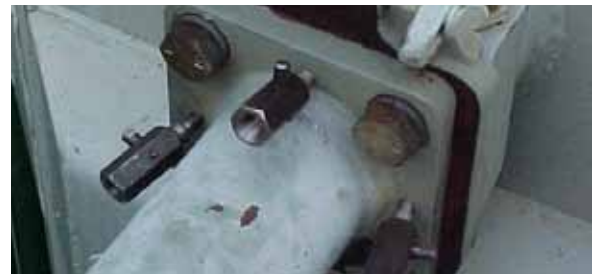
A common oil leak on a transformer is a flapper valve flange. These oil leaks are repaired using our Drill and Tap technique. After the injection is complete, the injectors are removed and Teflon-coated pipe plugs are installed.

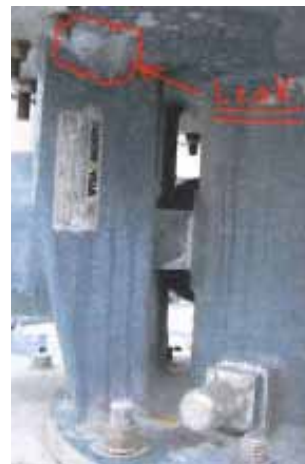
The leak is a casting flaw pin hole. COLT Power Services offered two repair options:

1. Take measurements and fabricate an enclosure that would close on the two flange ODs and encapsulate the leak. Then inject the enclosure with S-22 sealant for the seal. OR
2. Locate the exact spot where the leak was and verify wall thickness of the component. Make a 1/16" drilled & taped hole at this spot. An injection valve would then be installed and pumped with sealant.

The customer chose #2 and the job was sealed.
