September 10, 2014

<u>REPORT ON SF6 LEAK REPAIR COMPLETED AT SOUTHERN CALIFORNIA</u> EDISON (SCE) VALLEY 115kV GIS - SECTION 119C

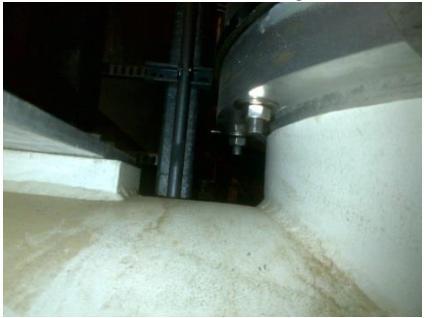
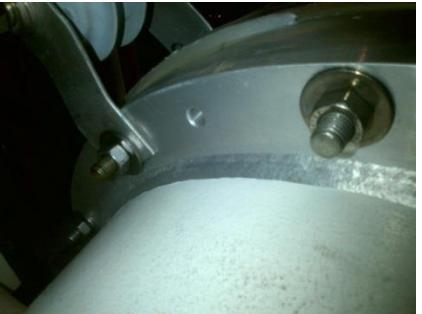
Inspection & Measurements

Colt technician made on-site inspection, took additional photos and precise measurements. (*See Diagram 2*)
